**Flood Control Project Maintenance  
Levee Inspections**  
**LMA District Cover Sheet**  
**Spring 2017 Levee Inspection Results**

**Reclamation District No. 0017 Mossdale**

**Levee Inspection Report By Mile - Spring 2017**

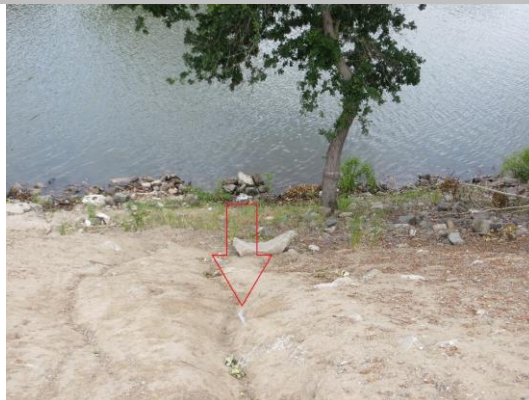
Photo 2 of 2 : UCIP\_SP\_2017\_45453\_74113.jpg

1.5-inch electrical conduit only appurtanance still visible on WS slope.

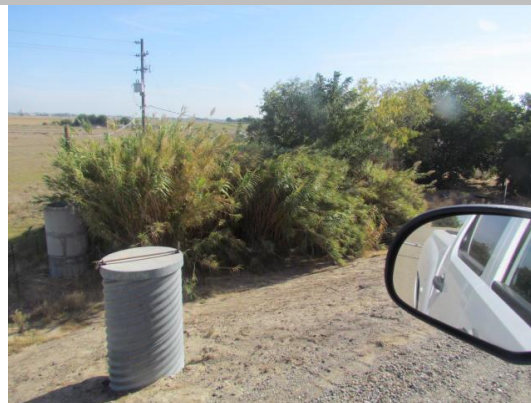
Photo 1 of 1 : SP\_2017\_RD0017\_304\_9\_20170316\_00005.jpg

LM Start	9.29	Rating **	M	Issue No.	9
LM End	9.29	Issue Type +	Ma	Location *	LS
Category	Earthen Levee			GPS Latitude/Longitude	
				Start	End
Item	Vegetation			37.815270 °	37.815270 °
				-121.317692 °	-121.317692 °
DWR ID	DWR_RD0017_02_s_2012_9				
Comment Code					
V4 : Elderberries are blocking visibility and flood fight capability.					
Inspector Comment					
Bamboo & elderberries at landside toe.

Looking east at bamboo and elderberries at landward toe.

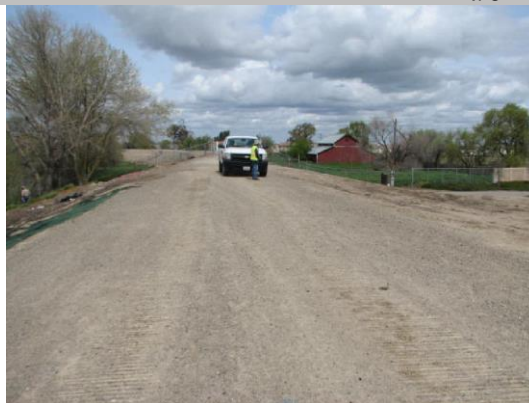
Photo 1 of 3 : UCIP\_SP\_2017\_40695\_72420.jpg

LM Start	11.31	Rating **	M	Issue No.	126
LM End	11.31	Issue Type +	En	Location *	LS
Category	Supplemental			GPS Latitude/Longitude	
				Start	End
Item	DWR UCIP Field Study			37.803410 °	37.803410 °
				-121.312031 °	-121.312031 °
DWR ID					
Comment Code					
Inspector Comment					
FS_ID:40695					
DS_ID:51					
EP_NO: 15055					
Repair Type: Non-Urgent					
Crossing Status: Found					
UCIP Comments: Pipe is not connected on waterward side. Crossing is non-functional recommend contacting owner to determine status of crossing. If crossing is no longer used need to coordinate with CVFPB for proper abandonment.					
FIELD_STRUCT_DESC: 16 inch diameter pipe through levee. Invert pipe is 3.91 feet below levee crown. Siphon breaker on landward shoulder. Slant pump on waterward slope, standpipe located 11 feet from the landward toe. (Permit No. 15055-1989)					
FS Date: 2/4/2010

Overview of levee crown at crossing.

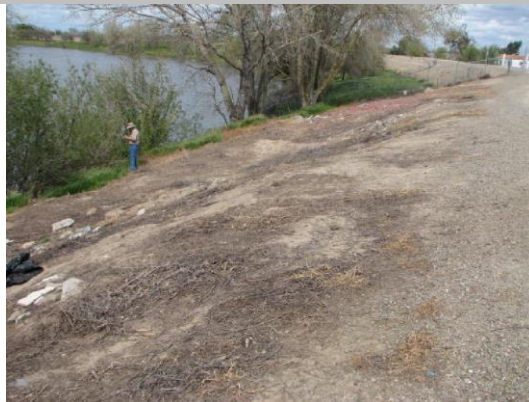
Photo 2 of 3 : UCIP\_SP\_2017\_40695\_72418.jpg

View of waterward side.

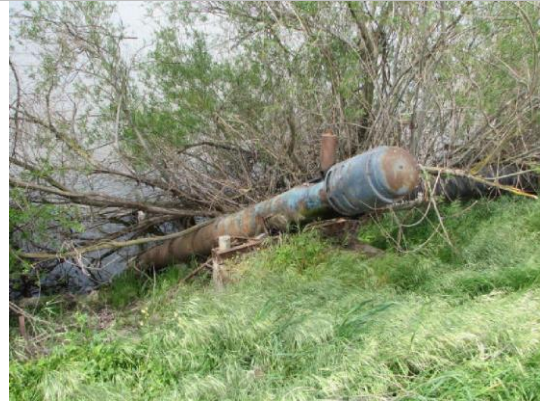
Photo 3 of 3 : UCIP\_SP\_2017\_40695\_72421.jpg

LM Start	11.31	Rating **	M	Issue No.	126 (cont)
LM End	11.31	Issue Type +	En	Location *	LS
Category	Supplemental			GPS Latitude/Longitude	
				Start	End
Item	DWR UCIP Field Study			37.803410 °	37.803410 °
				-121.312031 °	-121.312031 °
DWR ID					
Comment Code					
Inspector Comment					
FS_ID:40695 DS_ID:51 EP_NO: 15055 Repair Type: Non-Urgent Crossing Status: Found UCIP Comments: Pipe is not connected on waterward side. Crossing is non-functional recommend contacting owner to determine status of crossing. If crossing is no longer used need to coordinate with CVFPB for proper abandonment. FIELD_STRUCT_DESC: 16 inch diameter pipe through levee. Invert pipe is 3.91 feet below levee crown. Siphon breaker on landward shoulder. Slant pump on waterward slope, standpipe located 11 feet from the landward toe. (Permit No. 15055-1989) FS Date: 2/4/2010

Slant pump located on waterward side.

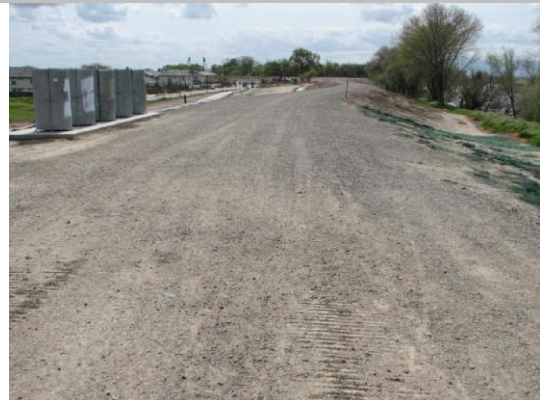
Photo 1 of 3 : UCIP\_SP\_2017\_40696\_72440.jpg

Overview of levee crown at crossing.

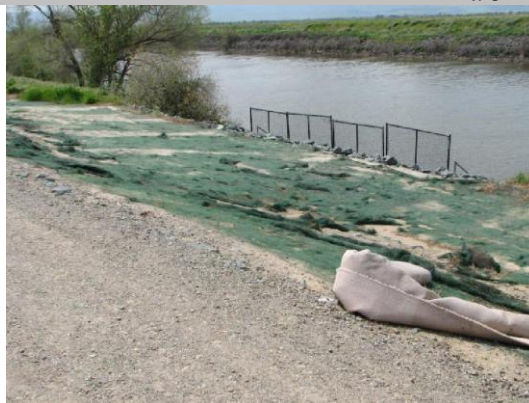
Photo 2 of 3 : UCIP\_SP\_2017\_40696\_72448.jpg

Item	DWR UCIP Field Study			37.802921 °		37.802921 °
				-121.311947 °		-121.311947 °
DWR ID						
Comment Code						
Inspector Comment						
FS_ID:40696						
DS_ID:103						
EP_NO: 17792						
Repair Type: Non-Urgent						
Crossing Status: Found						
UCIP Comments: Surface erosion on waterward slope--Need to contact owner.						
FIELD_STRUCT_DESC: 1 of 6. 30-inch diameter drainage pipe through levee at unknown depth. Struction is part of Lathrop City Stormwater Pump Station 112. Station consists 6 drainage pipes, pump station, air release valves, and concrete headwall. Air release valves located inside risers are located on landward shoulder on top of concrete pad. Concrete headwall and gates located on waterward side. (Permit No. 17792, 2005)						
FS Date: 2/4/2010

View of waterward side geotech fabric damage along slope.

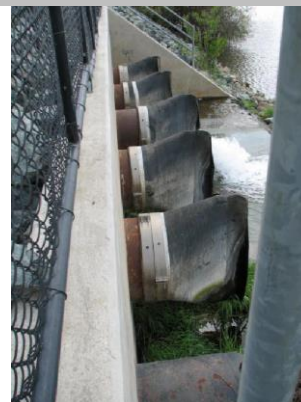
Photo 3 of 3 : UCIP\_SP\_2017\_40696\_72449.jpg

Concrete headwall and gates located on waterward toe.

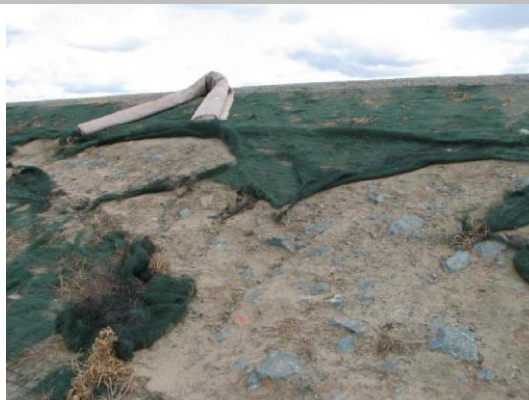
Photo 2 of 3 : UCIP\_SP\_2017\_40697\_72453.jpg

Comment Code					
Inspector Comment					
FS_ID:40697					
DS_ID:473					
EP_NO: 17792					
Repair Type: Non-Urgent					
Crossing Status: Found					
UCIP Comments: Surface erosion on waterward slope--need to contact owner.					
FIELD_STRUCT_DESC: 2 of 6. 30-inch diameter drainage pipe through levee at unknown depth. Struction is part of Lathrop City Stormwater Pump Station 112. Station consists 6 drainage pipes, pump station, air release valves, and concrete headwall. Air release valves located inside risers are located on landward shoulder on top of concrete pad. Concrete headwall and gates located on waterward side. (Permit No. 17792, 2005)					
FS Date: 2/4/2010

Geotech fabric damage along waterward berm.

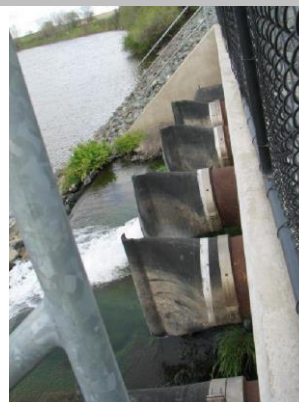
Photo 3 of 3 : UCIP\_SP\_2017\_40698\_72474.jpg

Outlet structure located on waterward toe.

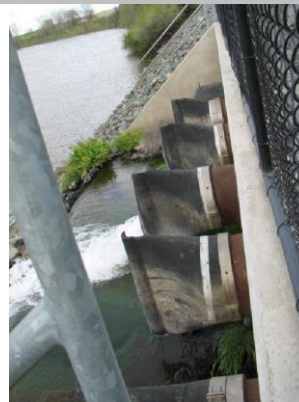
Photo 2 of 3 : UCIP\_SP\_2017\_40701\_72469.jpg

Outlet concrete headwall and gates on waterward toe.

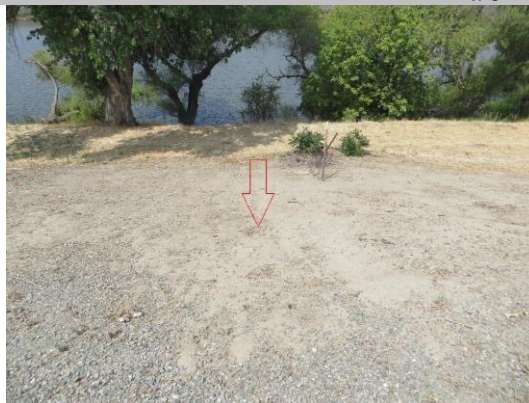
Photo 2 of 3 : UCIP\_SP\_2017\_45463\_74121.jpg

Vent visible on WS slope. Found partially burried.

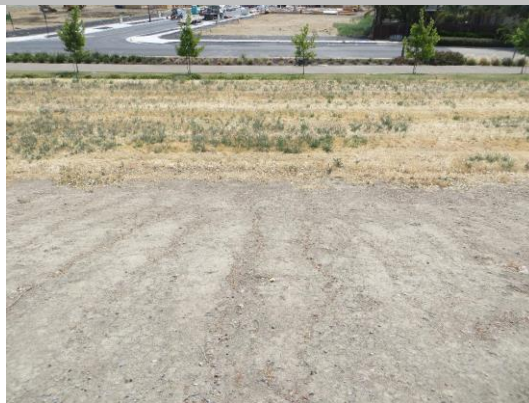
Photo 3 of 3 : UCIP\_SP\_2017\_45463\_74120.jpg

LS slope. No indication of pipe.

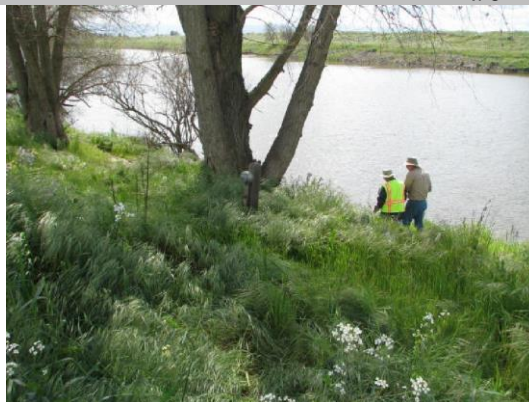
Photo 3 of 3 : UCIP\_SP\_2017\_40702\_72483.jpg

Comment Code					
Inspector Comment					
FS_ID:40702					
DS_ID:806					
EP_NO: N/A					
Repair Type: Non-Urgent					
Crossing Status: Found					
UCIP Comments: No pipe found during site visit only air valve and power meter. Dense vegetation along waterward slope recommend clearing vegetation from slope to conduct proper pipe inspection. If crossing is no longer in use owner will need to coordinate with DWR inspector and CVFPB to remove according to Title 23 requirements.					
FIELD_STRUCT_DESC: *REMOVED* 20-inch Steel drain pipe through the levee 5-feet below the crown. Siphon breaker in steel riser on WS shoulder and a flap gate on the WS toe Permit No. 3799, 1961. Pipe removed under Permit No. 15318, 1989. Drainage or Irrigation Structure referenced in O&M manual (HLM 12.16). (USACE O&M, 1963)					
FS Date: 2/4/2010

Dense vegetation along waterward slope--abandoned electrical box is visible through dense vegetation.

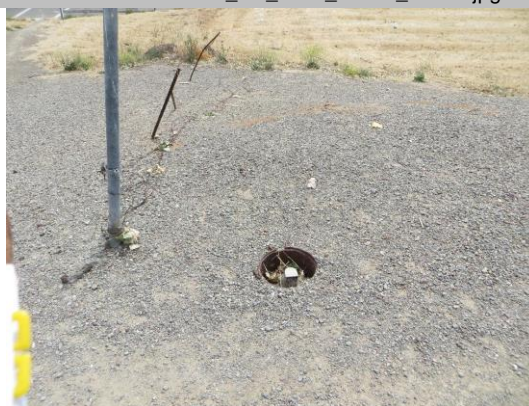
Photo 1 of 3 : UCIP\_SP\_2017\_45464\_74125.jpg

Vent in steel riser on LS shoulder.

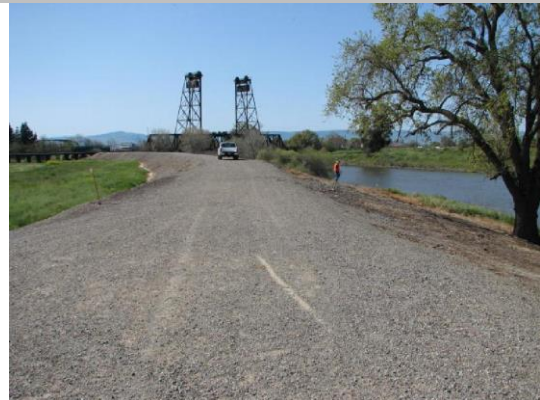
Photo 1 of 3 : UCIP\_SP\_2017\_40706\_72509.jpg

LM Start	12.41	Rating **	M	Issue No.	139
LM End	12.41	Issue Type +	En	Location *	LS
Category	Supplemental			GPS Latitude/Longitude	
				Start	End
Item	DWR UCIP Field Study			37.789976 °	37.789976 °
				-121.306853 °	-121.306853 °
DWR ID					
Comment Code					
Inspector Comment					
FS_ID:40706 DS_ID:807 EP_NO: N/A Repair Type: Non-Urgent Crossing Status: Found UCIP Comments: Pipe disconnected on waterward side. Need to contact owner to determine status of crossing. If crossing is no longer in use owner will need to coordinate with DWR inspector and CVFPB to remove according to Title 23 requirements. FIELD_STRUCT_DESC: 8 inch pipe through levee 3.2-feet below the crown. Pump on WS toe and a siphon breaker on the LS shoulder (Permit No. 15049, 1989). Permit was for 6-inch pipe. FS Date: 2/4/2010

Overview of levee crown at crossing.

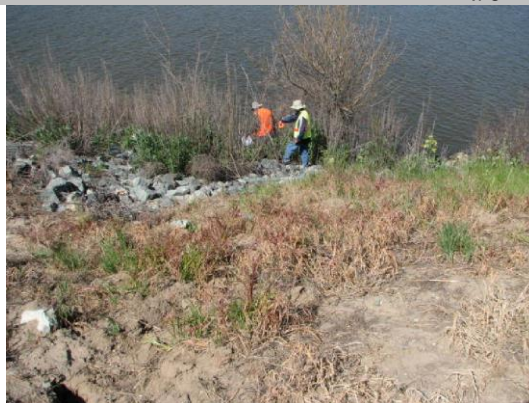
Photo 2 of 3 : UCIP\_SP\_2017\_40706\_72511.jpg

LM Start	12.41	Rating **	M	Issue No.	139 (cont)	
LM End	12.41	Issue Type +	En	Location *	LS	
Category	Supplemental			GPS Latitude/Longitude		
				Start		End
Item	DWR UCIP Field Study			37.789976 °	37.789976 °	
				-121.306853 °	-121.306853 °	
DWR ID						
Comment Code						
Inspector Comment						
FS_ID:40706						
DS_ID:807						
EP_NO: N/A						
Repair Type: Non-Urgent						
Crossing Status: Found						
UCIP Comments: Pipe disconnected on waterward side. Need to contact owner to determine status of crossing. If crossing is no longer in use owner will need to coordinate with DWR inspector and CVFPB to remove according to Title 23 requirements.						
FIELD_STRUCT_DESC: 8 inch pipe through levee 3.2-feet below the crown. Pump on WS toe and a siphon breaker on the LS shoulder (Permit No. 15049, 1989). Permit was for 6-inch pipe.						
FS Date: 2/4/2010

View of waterward toe--rip rap along pipe alignment.

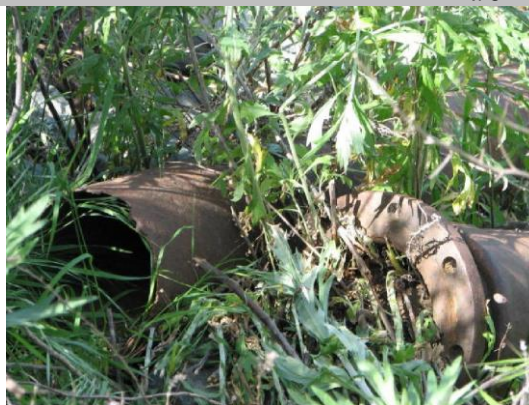
Photo 3 of 3 : UCIP\_SP\_2017\_40706\_72512.jpg

Non-functional crossing pipe disconnected.

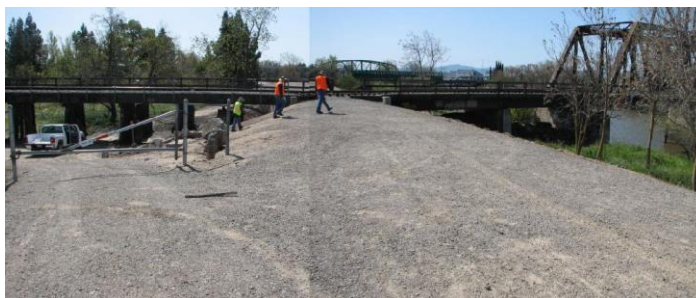
Photo 1 of 3 : UCIP\_SP\_2017\_40707\_72515.jpg

LM Start	12.55	Rating **	M	Issue No.	140
LM End	12.55	Issue Type +	En	Location *	LS
Category	Supplemental			GPS Latitude/Longitude	
				Start	End
Item	DWR UCIP Field Study			37.787929 °	37.787929 °
				-121.307173 °	-121.307173 °
DWR ID					
Comment Code					
Inspector Comment					
FS_ID:40707					
DS_ID:60					
EP_NO: 14326					
Repair Type: Non-Urgent					
Crossing Status: Indicator Found					
UCIP Comments: Wires exposed near levee crown unable to determine if these wires are part of the crossing. Need to contact owner to determine status of crossing.					
FIELD_STRUCT_DESC: 4 inch diameter communication cable through levee. Invert of conduit is 3.0 feet below levee crown. (Permit No. 14326-1986)					
FS Date: 2/4/2010

Overview of levee crown at crossing.

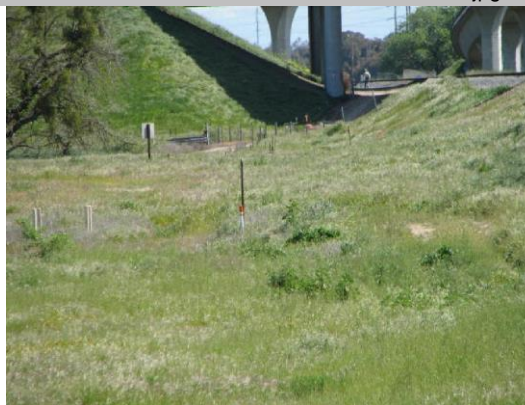
Photo 2 of 3 : UCIP\_SP\_2017\_40707\_72514.jpg

Crossing alignment along landward side.

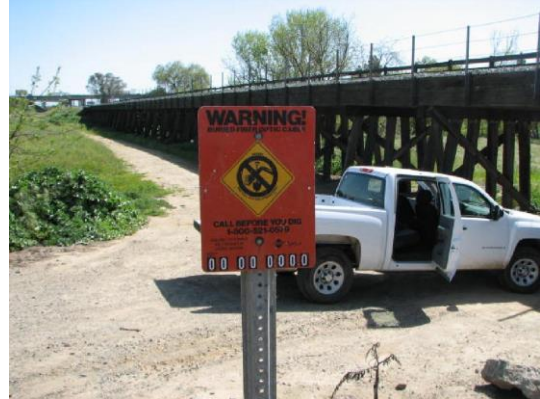
Photo 3 of 3 : UCIP\_SP\_2017\_40707\_72513.jpg

LM Start	12.55	Rating **	M	Issue No.	140 (cont)	
LM End	12.55	Issue Type +	En	Location *	LS	
Category	Supplemental			GPS Latitude/Longitude		
				Start		End
Item	DWR UCIP Field Study			37.787929 °		37.787929 °
				-121.307173 °		-121.307173 °
DWR ID						
Comment Code						
Inspector Comment						
FS_ID:40707						
DS_ID:60						
EP_NO: 14326						
Repair Type: Non-Urgent						
Crossing Status: Indicator Found						
UCIP Comments: Wires exposed near levee crown unable to determine if these wires are part of the crossing. Need to contact owner to determine status of crossing.						
FIELD_STRUCT_DESC: 4 inch diameter communication cable through levee. Invert of conduit is 3.0 feet below levee crown. (Permit No. 14326-1986)						
FS Date: 2/4/2010

Conduit marker on landward side.

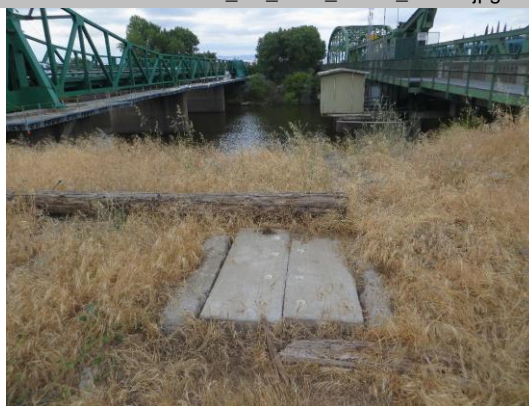
Photo 2 of 3 : UCIP\_SP\_2017\_45466\_74131.jpg

Item	DWR UCIP Field Study			37.786343 °	37.786343 °	
				-121.306157 °	-121.306157 °	
DWR ID						
Comment Code						
Inspector Comment						
FS_ID:45466						
DS_ID:808						
EP_NO: 2366						
Repair Type: Non-Urgent						
Crossing Status: Found						
UCIP Comments: Pipe exposed on WS slope where soil has been removed from around pipe. There does not appear to be any damage or repair at excavation. Pipe should be buried.						
FIELD_STRUCT_DESC: 22-inch diameter steel stormdrain pipe through the levee 10-feet below levee crown. 54-inch square, concrete manhole at the centerline of the levee between Manthey Road and the HWY 120 onramp to I-5. (Order of the Board No. 2366-1956) (Pipe listed as 22-inch in Permit).						
FS Date: 5/21/2015

Concrete manhole on WS shoulder.

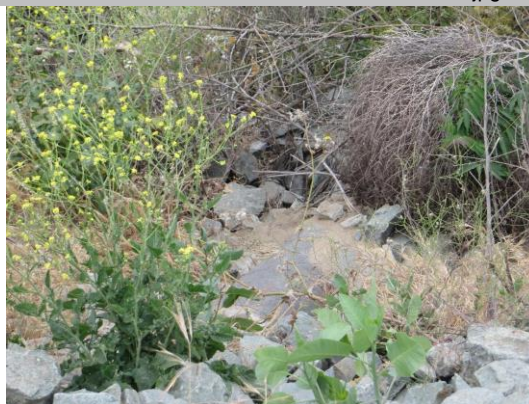
Photo 3 of 3 : UCIP\_SP\_2017\_45466\_74130.jpg

Pipe exposed in excavated area on WS slope.

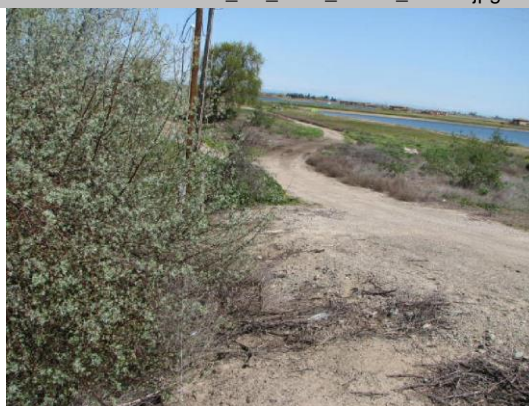
Photo 1 of 3 : UCIP\_SP\_2017\_40712\_72529.jpg

LM Start	13.26	Rating **	M	Issue No.	142
LM End	13.26	Issue Type +	En	Location *	LS
Category	Supplemental			GPS Latitude/Longitude	
				Start	End
Item	DWR UCIP Field Study			37.779653 °	37.779653 °
				-121.300064 °	-121.300064 °
DWR ID					
Comment Code					
Inspector Comment					
FS_ID:40712					
DS_ID:65					
EP_NO: 14450					
Repair Type: Non-Urgent					
Crossing Status: Found					
UCIP Comments: Need to contact owner to determine status of crossing.					
FIELD_STRUCT_DESC: 1 of 2: 18 inch diameter drainage discharge pipes through levee. (Permit No. 14450-1985)					
FS Date: 2/4/2010

View of landward side.

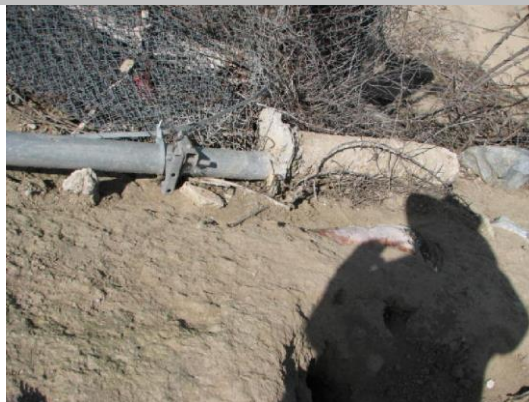
Photo 2 of 3 : UCIP\_SP\_2017\_40712\_72528.jpg

Pipe section exposed on landward side.

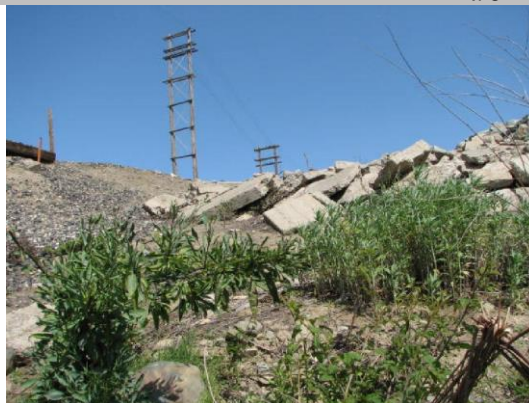
Photo 3 of 3 : UCIP\_SP\_2017\_40712\_72530.jpg

LM Start	13.26	Rating **	M	Issue No.	142 (cont)	
LM End	13.26	Issue Type +	En	Location *	LS	
Category	Supplemental			GPS Latitude/Longitude		
				Start	End	
Item	DWR UCIP Field Study			37.779653 °	37.779653 °	
				-121.300064 °	-121.300064 °	
DWR ID						
Comment Code						
Inspector Comment						
FS_ID:40712						
DS_ID:65						
EP_NO: 14450						
Repair Type: Non-Urgent						
Crossing Status: Found						
UCIP Comments: Need to contact owner to determine status of crossing.						
FIELD_STRUCT_DESC: 1 of 2: 18 inch diameter drainage discharge pipes through levee. (Permit No. 14450-1985)						
FS Date: 2/4/2010

View of waterward slope.

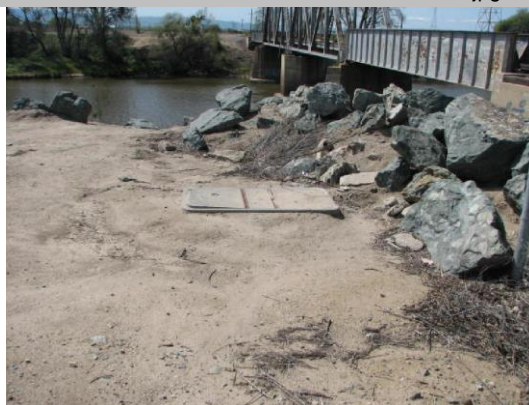
Photo 1 of 3 : UCIP\_SP\_2017\_40713\_72534.jpg

LM Start	13.26	Rating **	M	Issue No.	143
LM End	13.26	Issue Type +	En	Location *	LS
Category	Supplemental			GPS Latitude/Longitude	
				Start	End
Item	DWR UCIP Field Study			37.779643 °	37.779643 °
				-121.300057 °	-121.300057 °
DWR ID					
Comment Code					
Inspector Comment					
FS_ID:40713 DS_ID:287 EP_NO: 14450 Repair Type: Non-Urgent Crossing Status: Found UCIP Comments: Need to contact owner to determine status of crossing. FIELD_STRUCT_DESC: 2 of 2: 18 inch diameter drainage discharge pipes through levee. (Permit No. 14450-1985) FS Date: 2/4/2010

Precast concrete box located on levee shoulder.

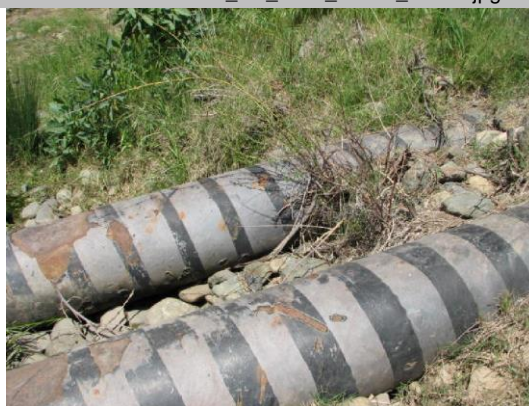
Photo 2 of 3 : UCIP\_SP\_2017\_40713\_72533.jpg

LM Start	13.26	Rating **	M	Issue No.	143 (cont)
LM End	13.26	Issue Type +	En	Location *	LS
Category	Supplemental			GPS Latitude/Longitude	
				Start	End
Item	DWR UCIP Field Study			37.779643 °	37.779643 °
				-121.300057 °	-121.300057 °
DWR ID					
Comment Code					
Inspector Comment					
FS_ID:40713 DS_ID:287 EP_NO: 14450 Repair Type: Non-Urgent Crossing Status: Found UCIP Comments: Need to contact owner to determine status of crossing. FIELD_STRUCT_DESC: 2 of 2: 18 inch diameter drainage discharge pipes through levee. (Permit No. 14450-1985) FS Date: 2/4/2010

Pipes visible on waterward side.

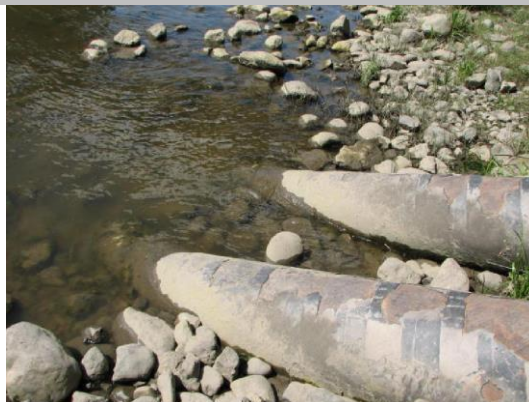
Photo 3 of 3 : UCIP\_SP\_2017\_40713\_72537.jpg

Sections of protective wrap missing near waterward toe.

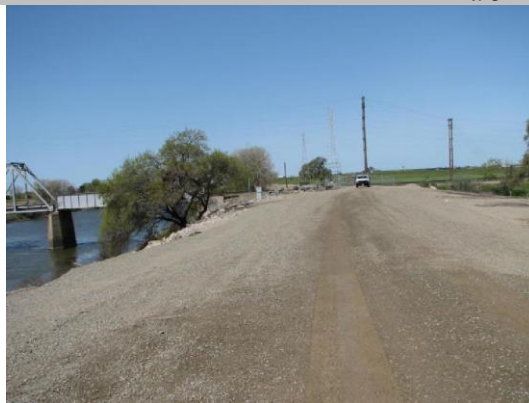
Photo 1 of 3 : UCIP\_SP\_2017\_40714\_72545.jpg

Comment Code					
Inspector Comment					
FS_ID:40714 DS_ID:66 EP_NO: 14467 Repair Type: Non-Urgent Crossing Status: Found UCIP Comments: Records show this crossing was suppose to be abandoned however, the drain pipe was operable during site visit. Need to contact owner to clarify if crossing that was abandoned was removed and replaced with current crossing. FIELD_STRUCT_DESC: 36 inch concrete discharge gravity municipal waterwater discharge through levee approximatley 23 feet below crown. The reinforced concrete outfall structure with sluice gate will be constructed within the pipeline at the waterward levee shoulder. (Permit No. 14467-1986) FS Date: 2/4/2010

Overview of levee crown at crossing.

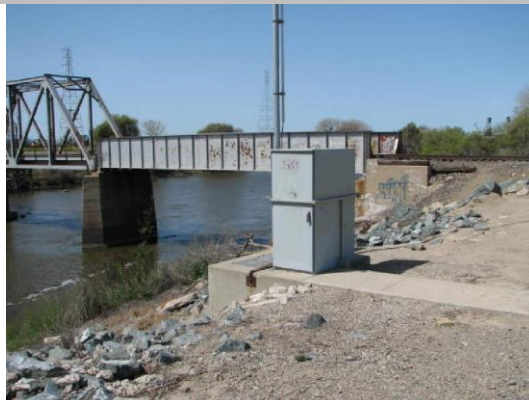
Photo 2 of 3 : UCIP\_SP\_2017\_40714\_72539.jpg

Control box and distribution box located on waterward shoulder.

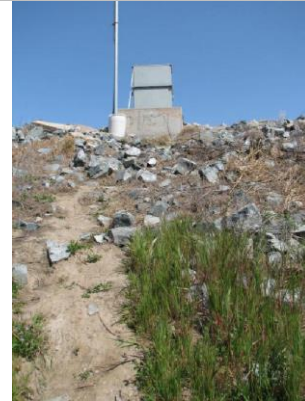
Photo 3 of 3 : UCIP\_SP\_2017\_40714\_72542.jpg

Item	DWR UCIP Field Study			37.779546 °	37.779546 °	
				-121.299981 °	-121.299981 °	
DWR ID						
Comment Code						
Inspector Comment						
FS_ID:40714 DS_ID:66 EP_NO: 14467 Repair Type: Non-Urgent Crossing Status: Found UCIP Comments: Records show this crossing was suppose to be abandoned however, the drain pipe was operable during site visit. Need to contact owner to clarify if crossing that was abandoned was removed and replaced with current crossing. FIELD_STRUCT_DESC: 36 inch concrete discharge gravity municipal waterwater discharge through levee approximatley 23 feet below crown. The reinforced concrete outfall structure with sluice gate will be constructed within the pipeline at the waterward levee shoulder. (Permit No. 14467-1986) FS Date: 2/4/2010

View of waterward side.

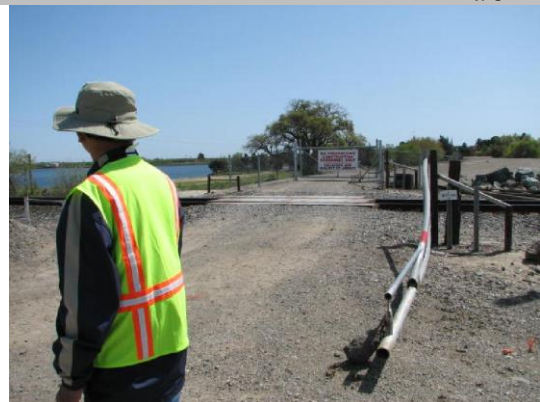
Photo 1 of 2 : UCIP\_SP\_2017\_45995\_72526.jpg

LM Start	13.28	Rating **	M	Issue No.	145
LM End	13.28	Issue Type +	En	Location *	LS
Category	Supplemental			GPS Latitude/Longitude	
				Start	End
Item	DWR UCIP Field Study			37.779470 °	37.779470 °
				-121.299954 °	-121.299954 °
DWR ID					
Comment Code					
Inspector Comment					
FS_ID:45995 DS_ID:67 EP_NO: N/A Repair Type: Non-Urgent Crossing Status: Indicator Found UCIP Comments: Markers visible on landward side only. Recommend contacting owner to confirm alignment and crossing. FIELD_STRUCT_DESC: Submarine power cable through the levee and across the channel. FS Date: 2/4/2010

View of levee crown at crossing.

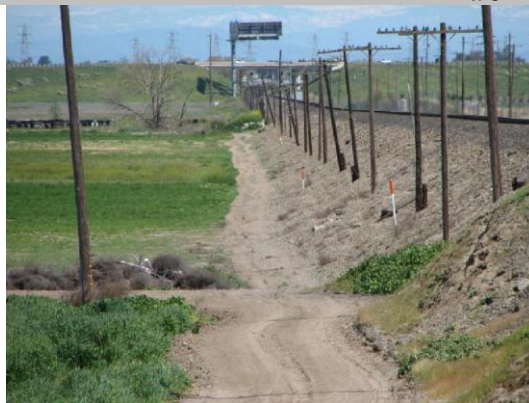
Photo 2 of 2 : UCIP\_SP\_2017\_45995\_72525.jpg

LM Start	13.28	Rating **	M	Issue No.	145 (cont)
LM End	13.28	Issue Type +	En	Location *	LS
Category	Supplemental			GPS Latitude/Longitude	
				Start	End
Item	DWR UCIP Field Study			37.779470 °	37.779470 °
				-121.299954 °	-121.299954 °
DWR ID					
Comment Code					
Inspector Comment					
FS_ID:45995 DS_ID:67 EP_NO: N/A Repair Type: Non-Urgent Crossing Status: Indicator Found UCIP Comments: Markers visible on landward side only. Recommend contacting owner to confirm alignment and crossing. FIELD_STRUCT_DESC: Submarine power cable through the levee and across the channel. FS Date: 2/4/2010

Markers visible along landward side.

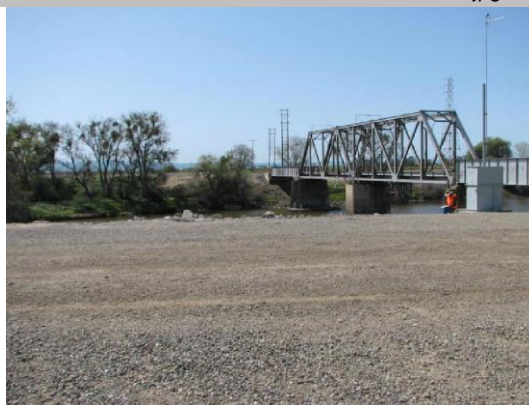
Photo 1 of 3 : UCIP\_SP\_2017\_40715\_72548.jpg

Comment Code					
Inspector Comment					
FS_ID:40715 DS_ID:809 EP_NO: N/A Repair Type: Non-Urgent Crossing Status: Found UCIP Comments: No information was obtained from desk study. This crossing was found during field visit. Need to contact owner to obtain additional details about crossing (installation date and permit) and status. FIELD_STRUCT_DESC: *ABANDONED* 18-inch pipe through the levee, 5.8 feet below the crown. Gate valve and siphon breaker on the waterward slope. Flap gate on the waterward end. One CM cutoff wall (Reclamation District No. 17 Drainage Plant). Pump on the landward side. Installed by USCE 1961. This entry matches the Drainage or Irrigation Structure referenced in O&M manual (HLM 13.36). (USACE O&M, 1963). Welded Steel plate installed over one end of pipe under Permit No. 14450, 1988. FS Date: 2/4/2010

View of levee crown at crossing.

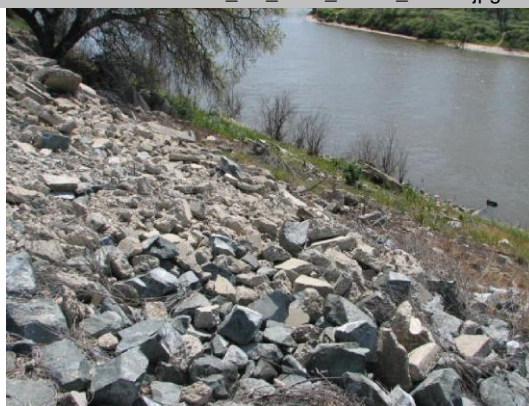
Photo 2 of 3 : UCIP\_SP\_2017\_40715\_72551.jpg

Item	DWR UCIP LMA Responsibility			37.779470 °	37.779470 °	
				-121.299954 °	-121.299954 °	
DWR ID						
Comment Code						
Inspector Comment						
FS_ID:40715 DS_ID:809 EP_NO: N/A Repair Type: Non-Urgent Crossing Status: Found UCIP Comments: No information was obtained from desk study. This crossing was found during field visit. Need to contact owner to obtain additional details about crossing (installation date and permit) and status. FIELD_STRUCT_DESC: *ABANDONED* 18-inch pipe through the levee, 5.8 feet below the crown. Gate valve and siphon breaker on the waterward slope. Flap gate on the waterward end. One CM cutoff wall (Reclamation District No. 17 Drainage Plant). Pump on the landward side. Installed by USCE 1961. This entry matches the Drainage or Irrigation Structure referenced in O&M manual (HLM 13.36). (USACE O&M, 1963). Welded Steel plate installed over one end of pipe under Permit No. 14450, 1988. FS Date: 2/4/2010

View of waterward side, photo 1 of 2.

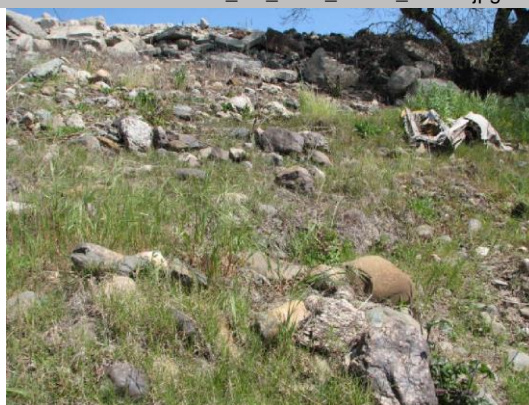
Photo 3 of 3 : UCIP\_SP\_2017\_40715\_72549.jpg

View of waterward side, photo 2 of 2.

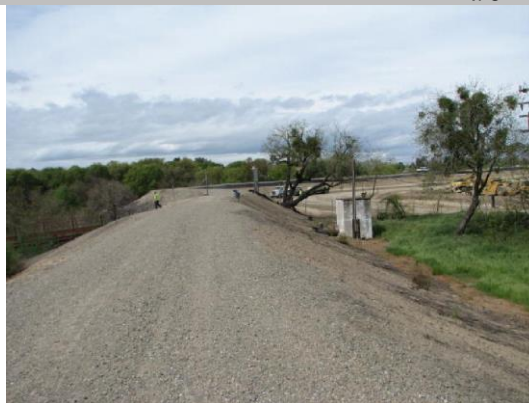
Photo 1 of 3 : UCIP\_SP\_2017\_40716\_72557.jpg

LM Start	14.20	Rating **	M	Issue No.	147
LM End	14.20	Issue Type +	En	Location *	LS
Category	Supplemental			GPS Latitude/Longitude	
				Start	End
Item	DWR UCIP Field Study			37.772267 °	37.772267 °
				-121.290202 °	-121.290202 °
DWR ID					
Comment Code					
Inspector Comment					
FS_ID:40716 DS_ID:69 EP_NO: 15165 Repair Type: Non-Urgent Crossing Status: Found UCIP Comments: Pump was working during the survey. Levee toe erosion at waterward side. Recommend contacting owner to determine status and to evaluate erosion at waterward toe. FIELD_STRUCT_DESC: 20-inch pipe through the levee, 1.7-feet below the crown. Pump on pile structure in the stream. Wooden walkway to the pump. concrete distribution box at the toe of the landward slope. (Permit No. 15165-1989) FS Date: 2/4/2010

Overview of levee crown at crossing.

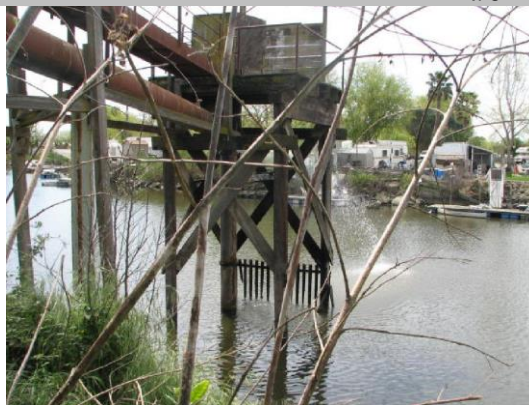
Photo 2 of 3 : UCIP\_SP\_2017\_40716\_72556.jpg

Pipe operable during survey.
